## MEMORANDUM

Subject: Proposed Residential Development  
3222 Albany Post Road, Village of Buchanan, NY  
Traffic Impact Memorandum

## **Sight Distance Exhibits**

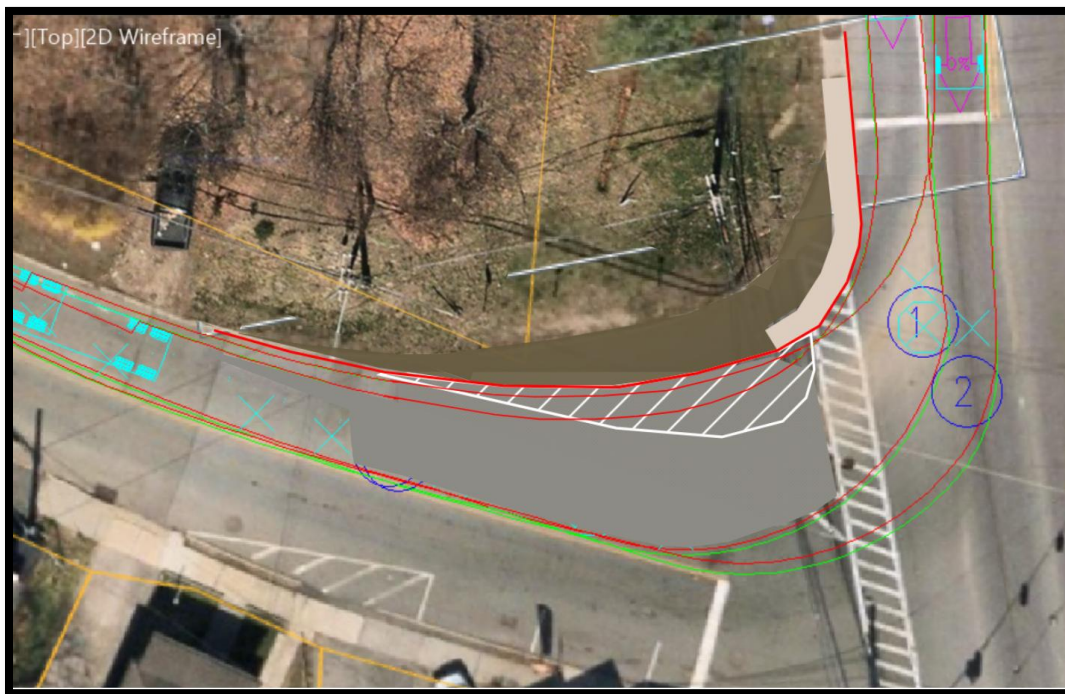
**Image 1: Suggested Modification to Westbound Bleakley Avenue at Albany Post Road (NYS Route 9A)**

Although the above analysis indicates that adequate intersection and stopping sight distances for this proposed 11-unit residential project are provided, conditions at the Project driveway on Bleakley Avenue could be improved if the westbound roadway leading away from the Albany Post Road (NYS Route 9A) & Bleakley Avenue intersection were restriped to provide a single lane, as opposed to the through lane and the yielding southbound right-turn lane that presently exist at the intersection (see **Image 1** below). The proposed improvement would eliminate the need for southbound right-turning motorists to yield to motorists who just turned left off of Albany Post Road (NYS Route 9A) onto Bleakley Avenue and, instead, focus on the road ahead of them. If the NYSDOT is willing to permit this restriping, it is recommended that it be implemented by the Project.

The sight distance evaluation also indicates that the available sight distances, with the identified maintenance and site preparation completed, at the proposed Project driveway on Bleakley Avenue satisfy the applicable minimum requirements for intersection and stopping sight distance based on the evaluated travel speeds and roadway conditions. While adequate sight distances are provided, a restriping of Bleakley Avenue has been recommended to improve motorist focus when making a southbound right turn from Albany Post Road (NYS Route 9A) onto Bleakley Avenue, if permitted by the NYSDOT.

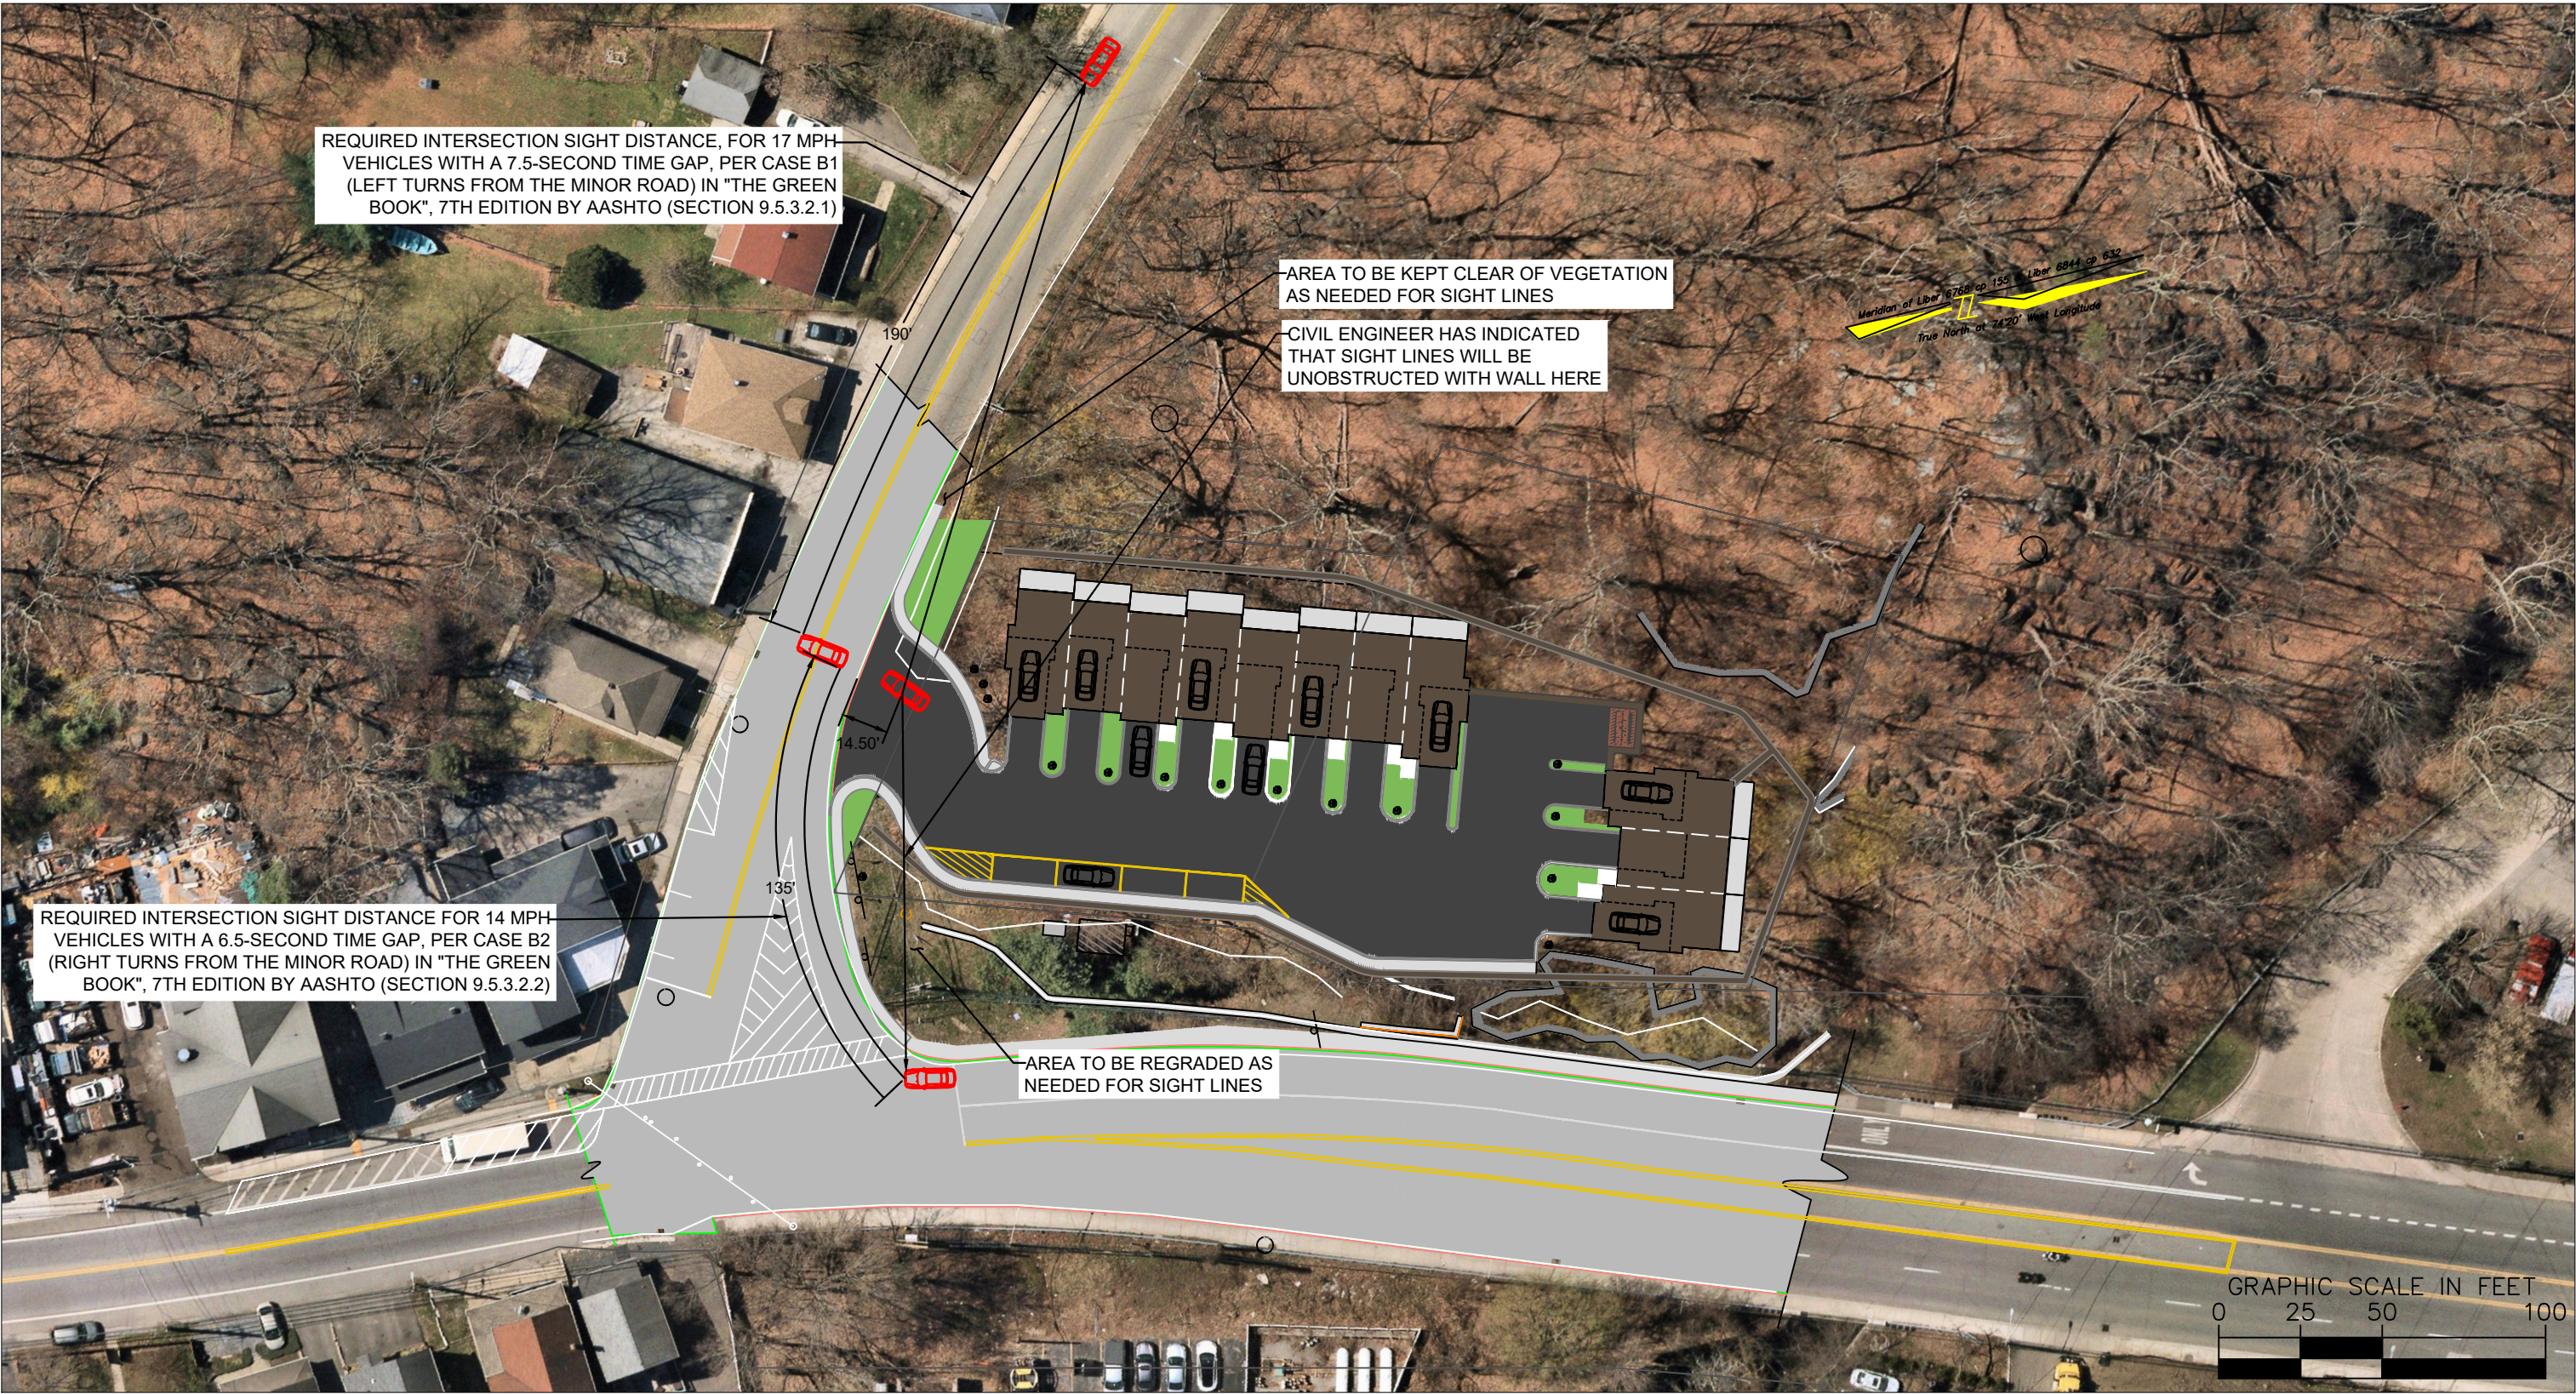
Intersection sight distance was measured along the path vehicles will travel within the acceptable time gap as they approach the Project driveway from either direction on Bleakley Avenue. The distances were measured from the viewpoint of a driver exiting the Project driveway (3.5 feet above the pavement and 14.5 feet back from the edge of the traveled way) to the approaching vehicles (also 3.5 feet above the pavement). It is noted that vehicles turning left from northbound Albany Post Road (NYS Route 9A) onto Bleakley Avenue will be visible for considerably more time than vehicles turning right from southbound Albany Post Road (NYS Route 9A). For this reason, the sight distance evaluation focused on the more critical movement, which was the southbound right-turning movement from Albany Post Road (NYS Route 9A) to Bleakley Avenue. Again, the analysis took into consideration the speeds of approaching vehicles on Bleakley Avenue, as well as the appropriate grade.

It is noted that, should motorists wish to increase their sight lines when they exit the site, they will have the ability to pull forward by approximately 4.5 feet and still have the front of their vehicle about 2 feet off the edge of the road (14.5 feet is the required measurement location; however, a motorist can be positioned 10 feet from the edge of the road while still having the front of the vehicle about 2 feet behind the edge of the traveled way on Bleakley Avenue).

Again, it is noted that motorists exiting the site could increase their sight lines, if they wished, by safely pulling forward by up to 4.5 feet.

For vehicles approaching the site driveway from the west (i.e., going eastbound) on Bleakley Avenue, it was determined that motorists exiting the site driveway would not “unduly interfere” with their progression if they are traveling at less than 18 MPH. For those motorists traveling at 18 MPH or more toward Bleakley Avenue’s intersection with Albany Post Road (NYS Route 9A), it was determined that the intersection sight distance limit of 190 feet would be acceptable because of the low volume of motorists exiting the driveway and because adequate sight distance would be provided to allow them to slow down as much as needed. Further, requiring these faster-traveling motorists to slow down was also determined not to be undue interference, since they would be slowing down as they approach the intersection of Bleakley Avenue with Albany Post Road (NYS Route 9A) anyway.
